Innovative and affordable service for PC monitoring of individual Cultural
Artefacts during display, storage, handling and transport

Validation report of “basic” sensor node to cloud, including analysis of data loss ratio, RSSI and LQI behaviour in each scenario

Deliverable number: D5.1

Project Acronym: CollectionCare

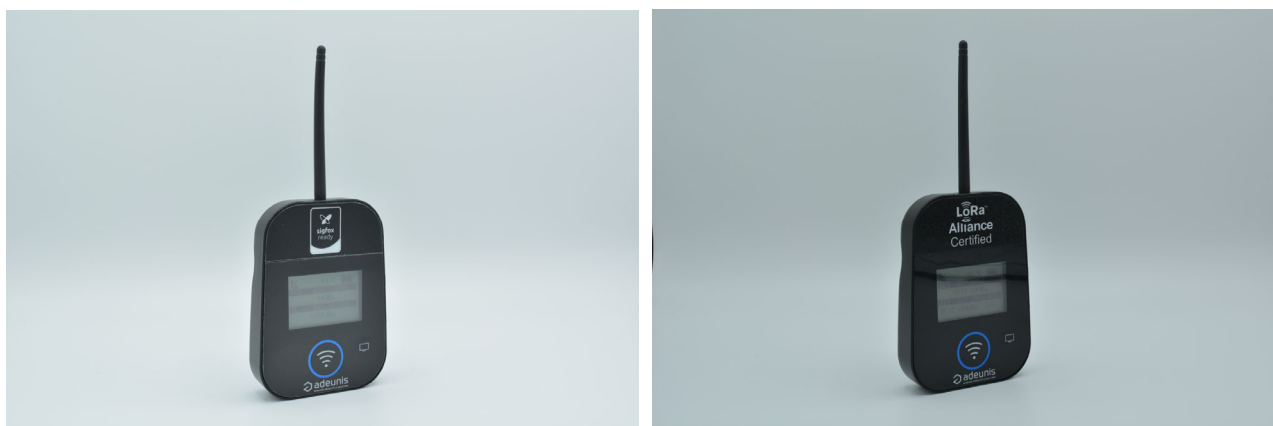
Figure 3. Field test devices for Sigfox (left) and for LoRaWAN (right) used in the test.

In our case, we used FTDs from the company Adeunis (www.adeunis.com/en/). Each communication technology requires a different type of FTD, so one is necessary for Sigfox and another for LoRaWAN in our case. Figure 3 shows the FTDs used.

Both FTDs were configured to use a power transmission at 14 dBm. For LoRaWAN, a SF12 spreading factor was fixed to allow maximum feasible distance evaluation.

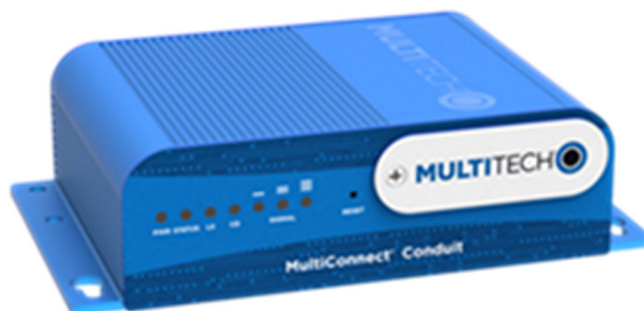
Figure 10. Test gateway utilized for radio mapping.

The next step was the installation of the modified gateway shown in Figure 10, which imitates the behaviour of a LoRaWAN network.

Based on our experience, this is not the best place for the gateway, but we were conditioned by the available installation resources. This should be taken into consideration in future deployments.

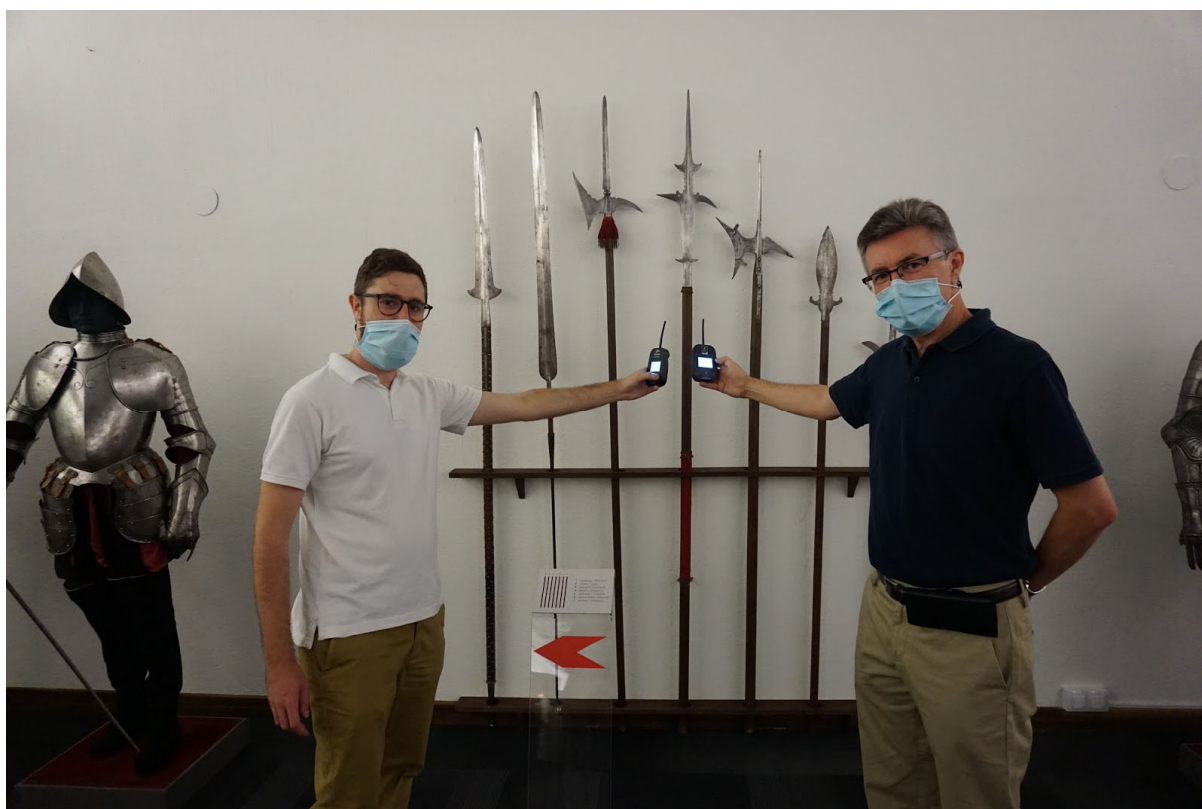
Figure 11. FTD test in the Alava Arms Museum.

Once the gateway was set up, most available spaces of the museum were tested using the FTD to gather as much information about RF transmission in the whole building as feasible. Each point was tested both for Sigfox and LoRaWAN, as shown in Figure 11, with a difference of a few seconds.

The measured values can be checked in the plans in Annex I.

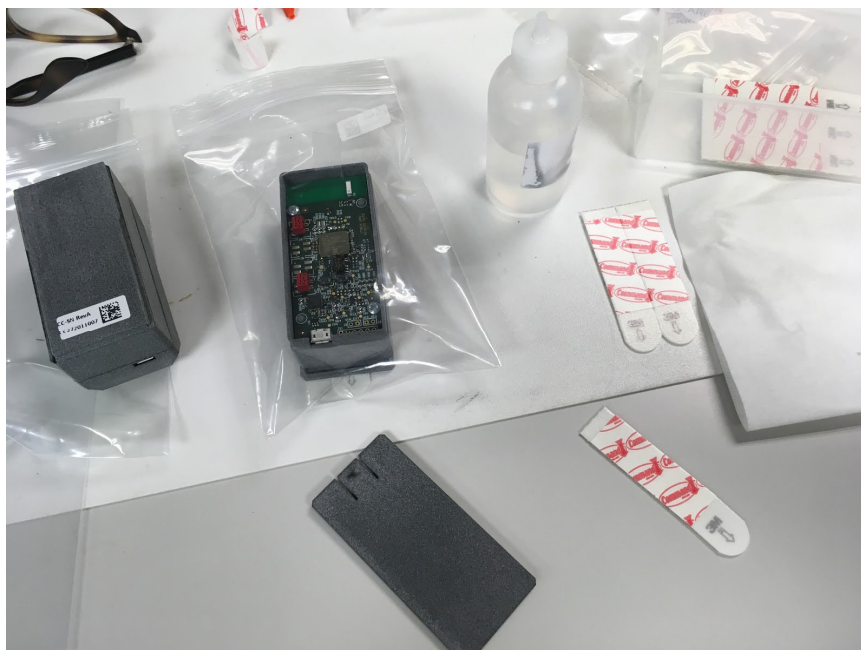
Figure 12. Parts of the sensor node and wall attachment equipment.

The nodes were placed on walls using double-sided reversible tape (3M command 17021P) or dropped near the piece or area of interest for exhibition displays and big artefacts. Figure 12 shows the aspect of the pieces comprising the sensor node, the double-sided tape and isopropyl alcohol to clean the surfaces where the nodes had to be attached.

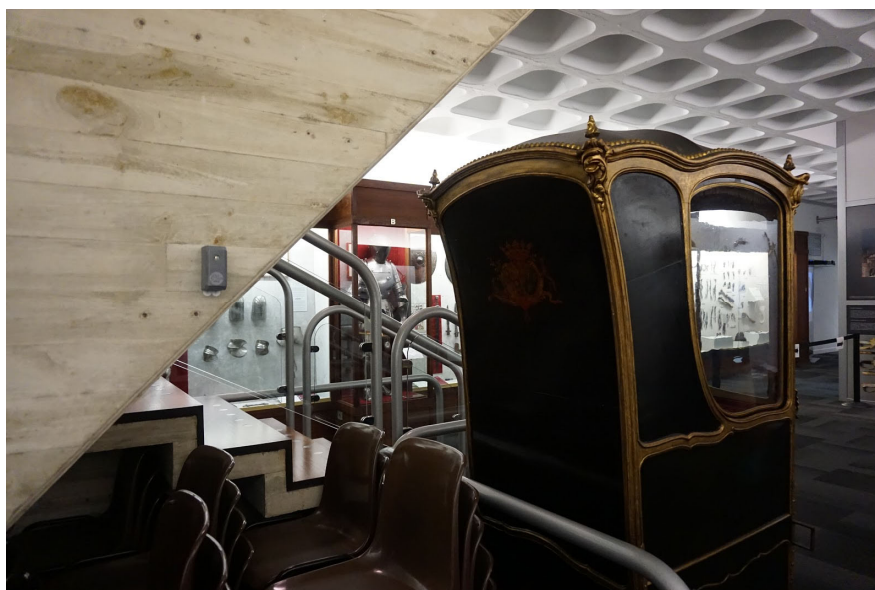
Figure 13. Sensor node attached to a reinforced concrete wall.

Figure 13 is an example of a sensor installed in a reinforced concrete wall. This deployment is of interest to check the behaviour of the reversible adhesive stripes used to attach the device.

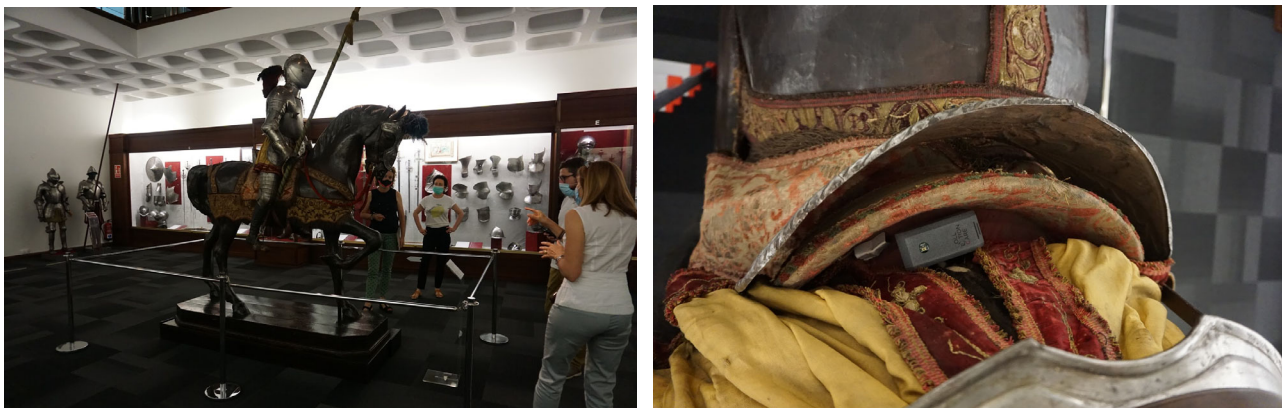
Figure 14. Artefact mainly composed of steel (left). Sensor installed in the artefact (right).

Figure 14 is an example of a sensor node dropped on a big artefact made mainly of steel, so it is especially interesting to test the behaviour of the wireless communications.

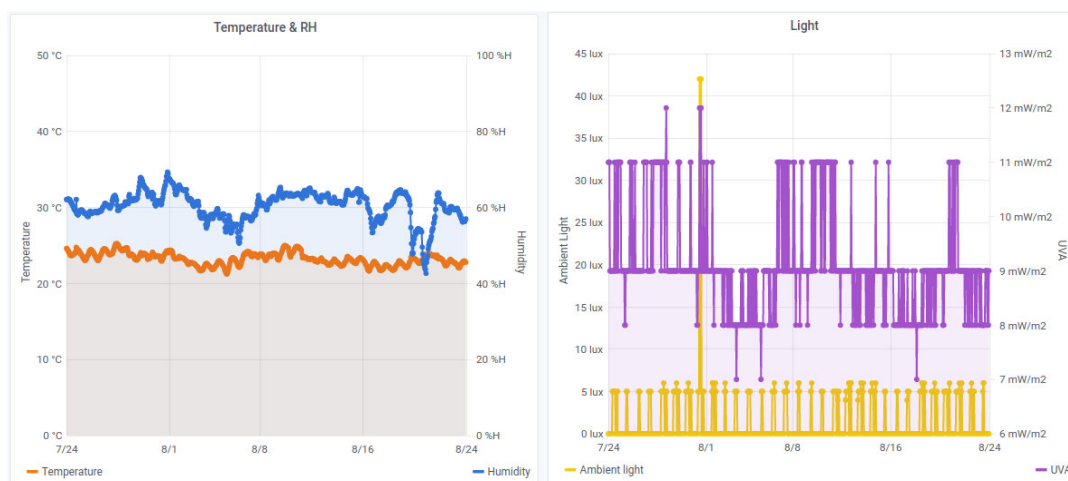
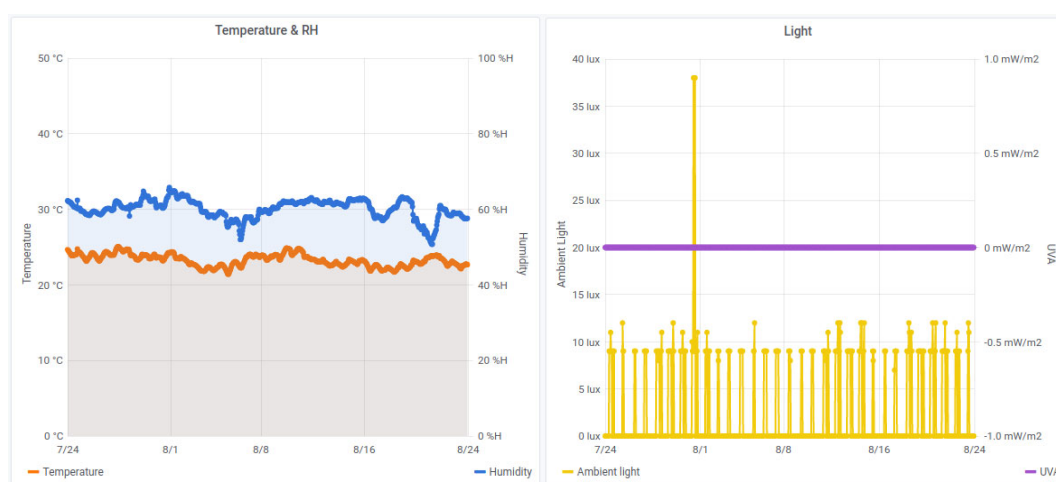
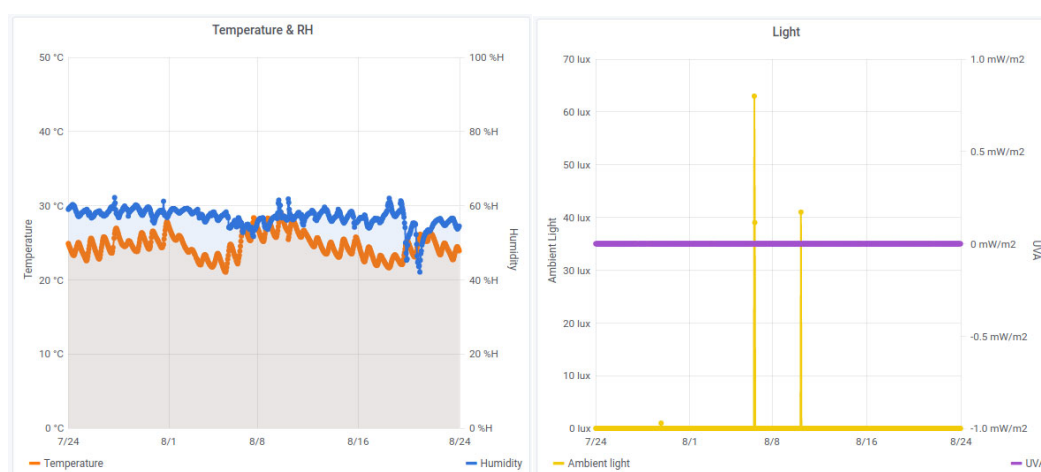
The sensor nodes were configured to collect and transmit temperature (T), relative humidity (RH), visible light (L) and ultraviolet radiation (UV) values at a sample interval of one hour.

For illustrative purposes only, the following Figures 16-20, captured from the web interface of the system, represent the values of temperature, relative humidity, light and ultraviolet radiation collected between 24 July and 24 August by the sensor node devices S01-S05 installed in the Alava Arms Museum. As mentioned above, the locations of these sensor nodes are indicated on the plans in Annex II.

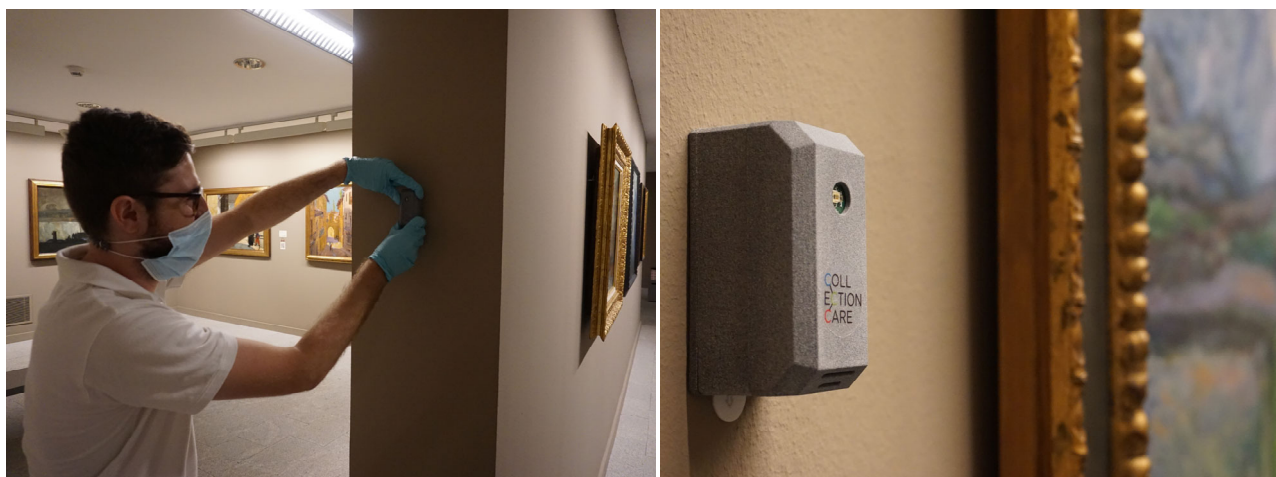
Figure 24. installation of sensor nodes in the Alava Fine Arts Museum.

All the sensor nodes were placed in walls using double-sided reversible tape. Figure 24 shows two examples of installed sensors.

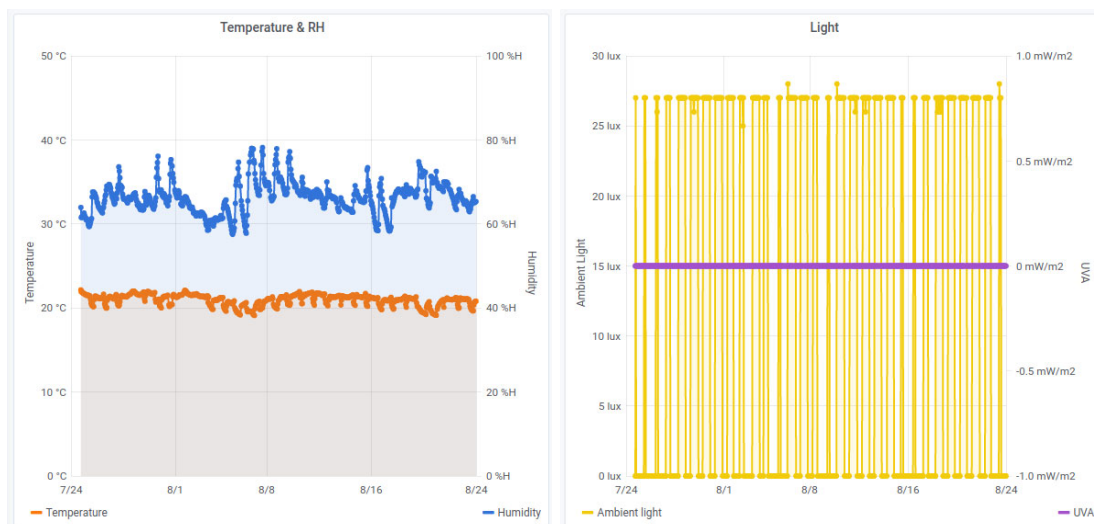
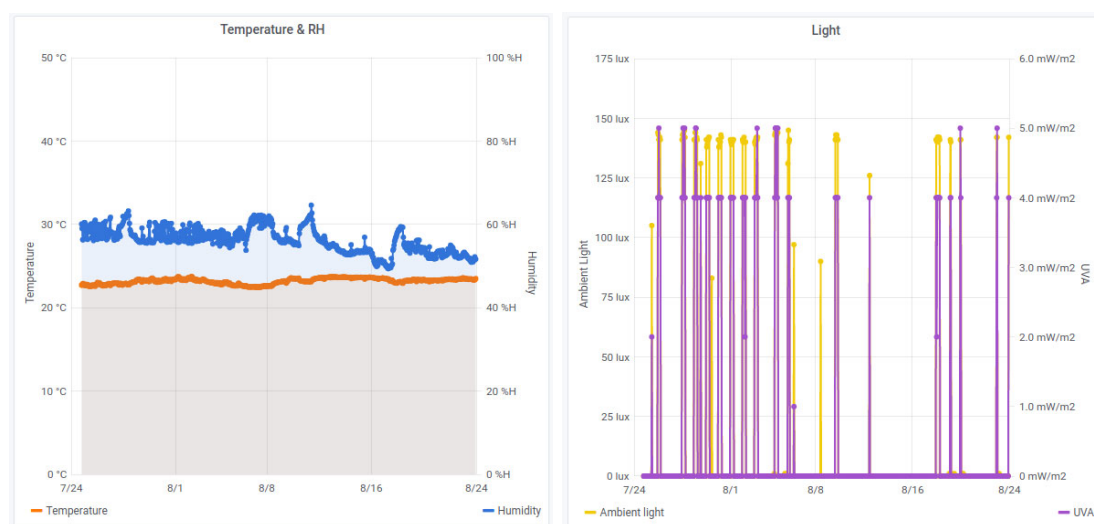
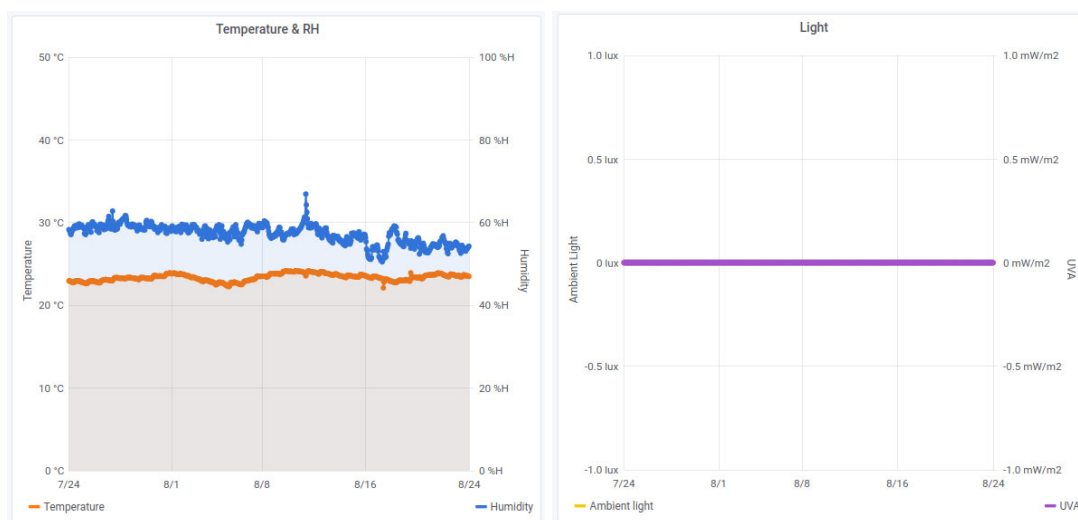
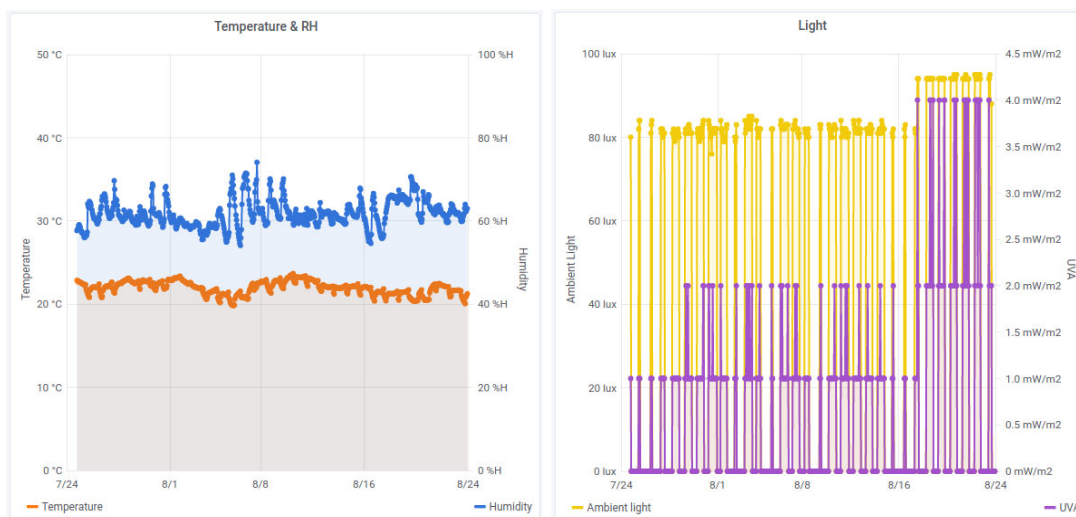
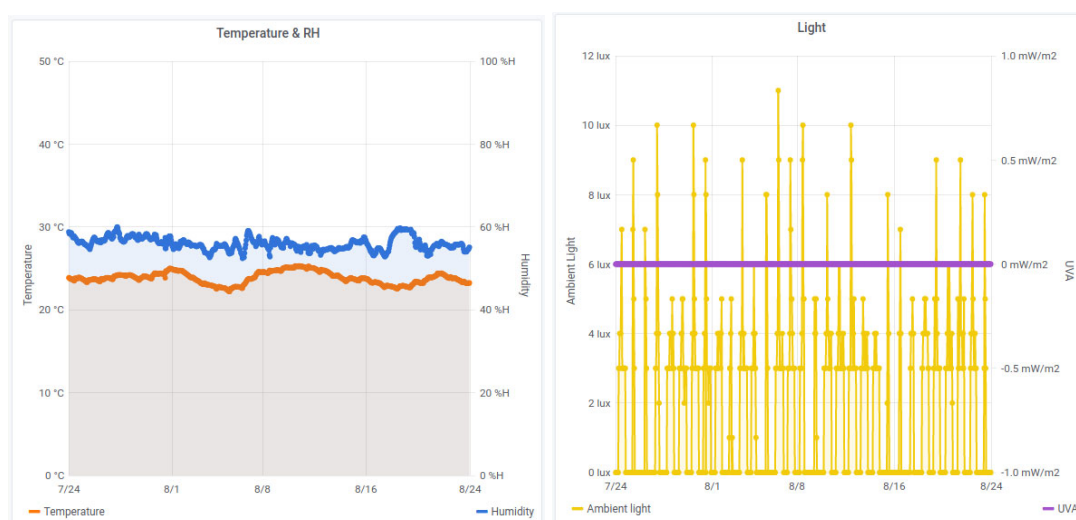
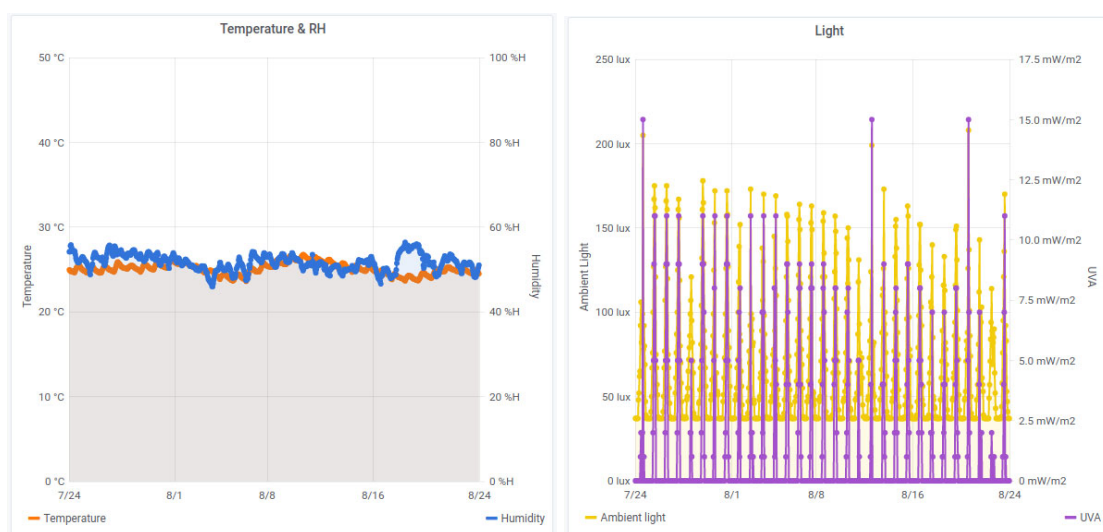
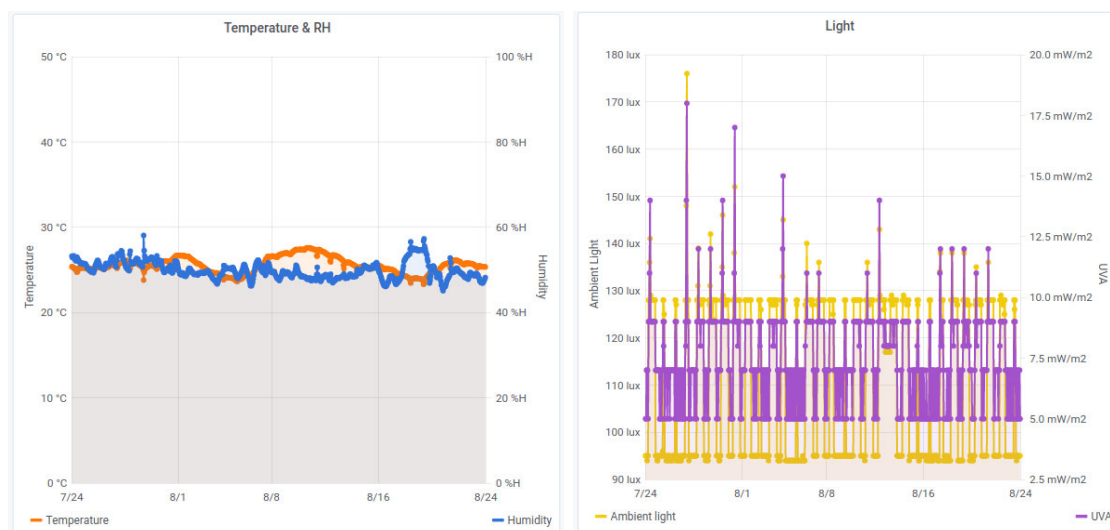
As with the Alava Arms Museum, the sensors were configured to collect and transmit temperature (T), relative humidity (RH), visible light (L) and ultraviolet radiation (UV) values at a sample interval of one hour.

For illustrative purposes only, the following Figures 25-34 captured from the web interface of the system, represents the values of T, RH, L and UV collected between 24 July and 24 August by the sensor node devices S01-S10 installed in the Alava Fine Arts Museum. As mentioned above, the locations of these sensor nodes are indicated on the plans in Annex II.

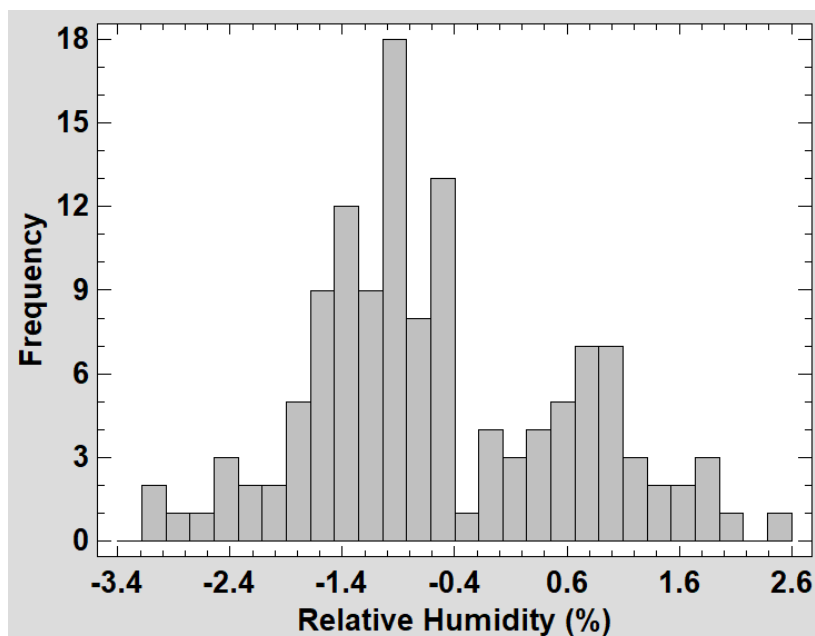
Figure 37. Histogram of the relative humidity differences between museum's datalogger and S02.

The median of the relative humidity recorded by the S02 device is 0.85% lower than the [museum device]. The maximum difference in RH is 2.4% and the minimum is -3.1%. The distribution of the differences is shown in Figure 37.

As can be seen in the histogram (Figure 37) and in the comparison between sensors once they are centred (Figure 38), the difference between the sensors is small (in most recordings there is no more than a 1% difference). The conditions of the installation and the datalogger do not allow for such a precise comparison as on previous occasions, but the great similarity between the records of the two sensors is easily appreciated.

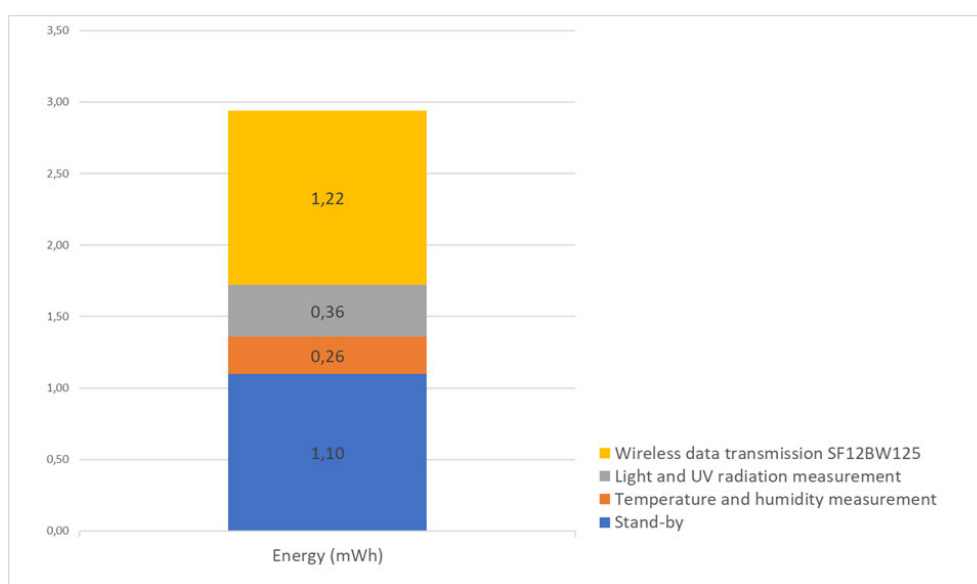
Figure 39. Estimated daily energy requirements of the sensor nodes installed in the DFA's museums.

- LoRaWAN only mode for wireless communications.
- Spreading factor 12, bandwidth of 125 kbps and output power of -14 dBm for LoRa radio.
- One transmission of data per hour.
- One sample per hour of temperature (T) and relative humidity (RH).
- One sample per hour for light (L) and ultraviolet radiation (UV).
- Battery voltage of 3.6 volts.

STATE	MEASURED VALUE	UNITS
Stand-by	12.7	μA
Temperature and humidity measurement	11.0	μWh
Light and UV radiation measurement	15.1	μWh
Wireless data transmission SF12BW125	50.8	μWh

STATE	ENERGY (mWh)
Stand-by	1.10
Temperature and humidity measurement	0.26
Light and UV radiation measurement	0.36
Wireless data transmission SF12BW125	1.22
